historic structure report

design and installation of a fire detection and suppression system
september 1983

YOSEMITE
WAWONA HOTEL

WAWONA HOTEL
YOSEMITE NATIONAL PARK
California

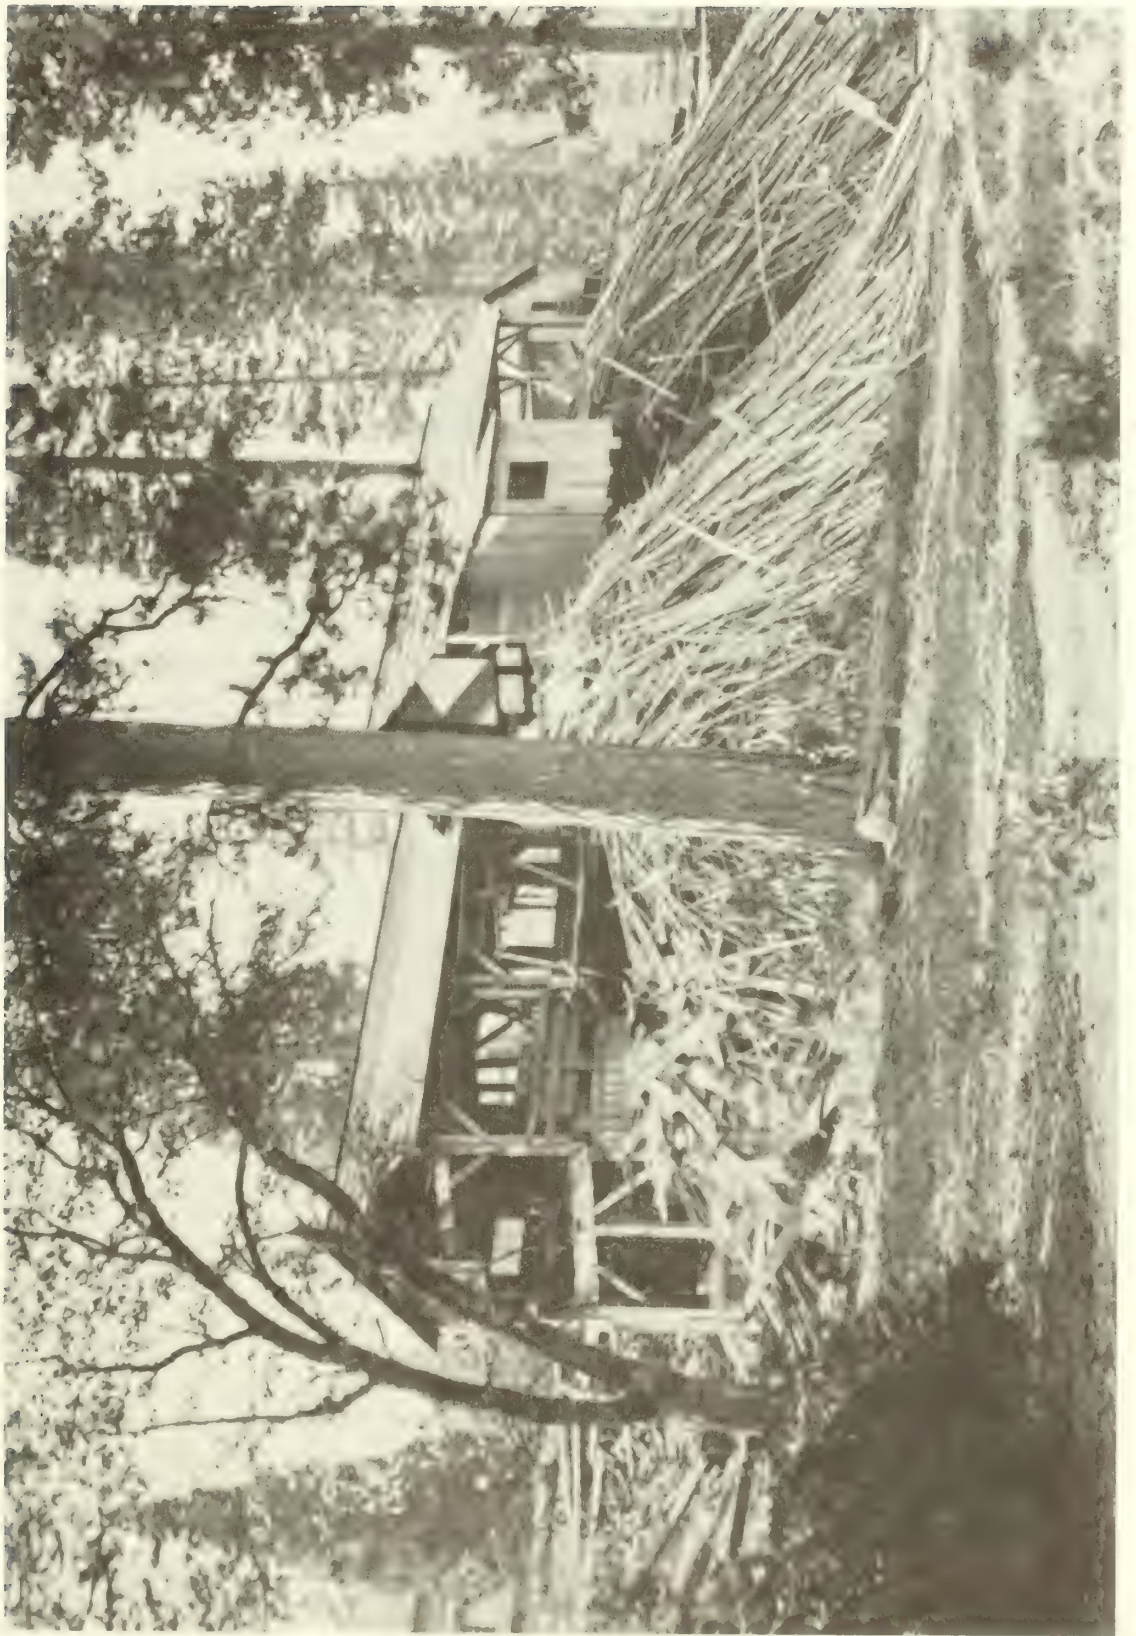
only as a workshop and place to display his paintings.⁴² Illustration 8, looking due north, shows the studio as it appeared shortly after its construction.

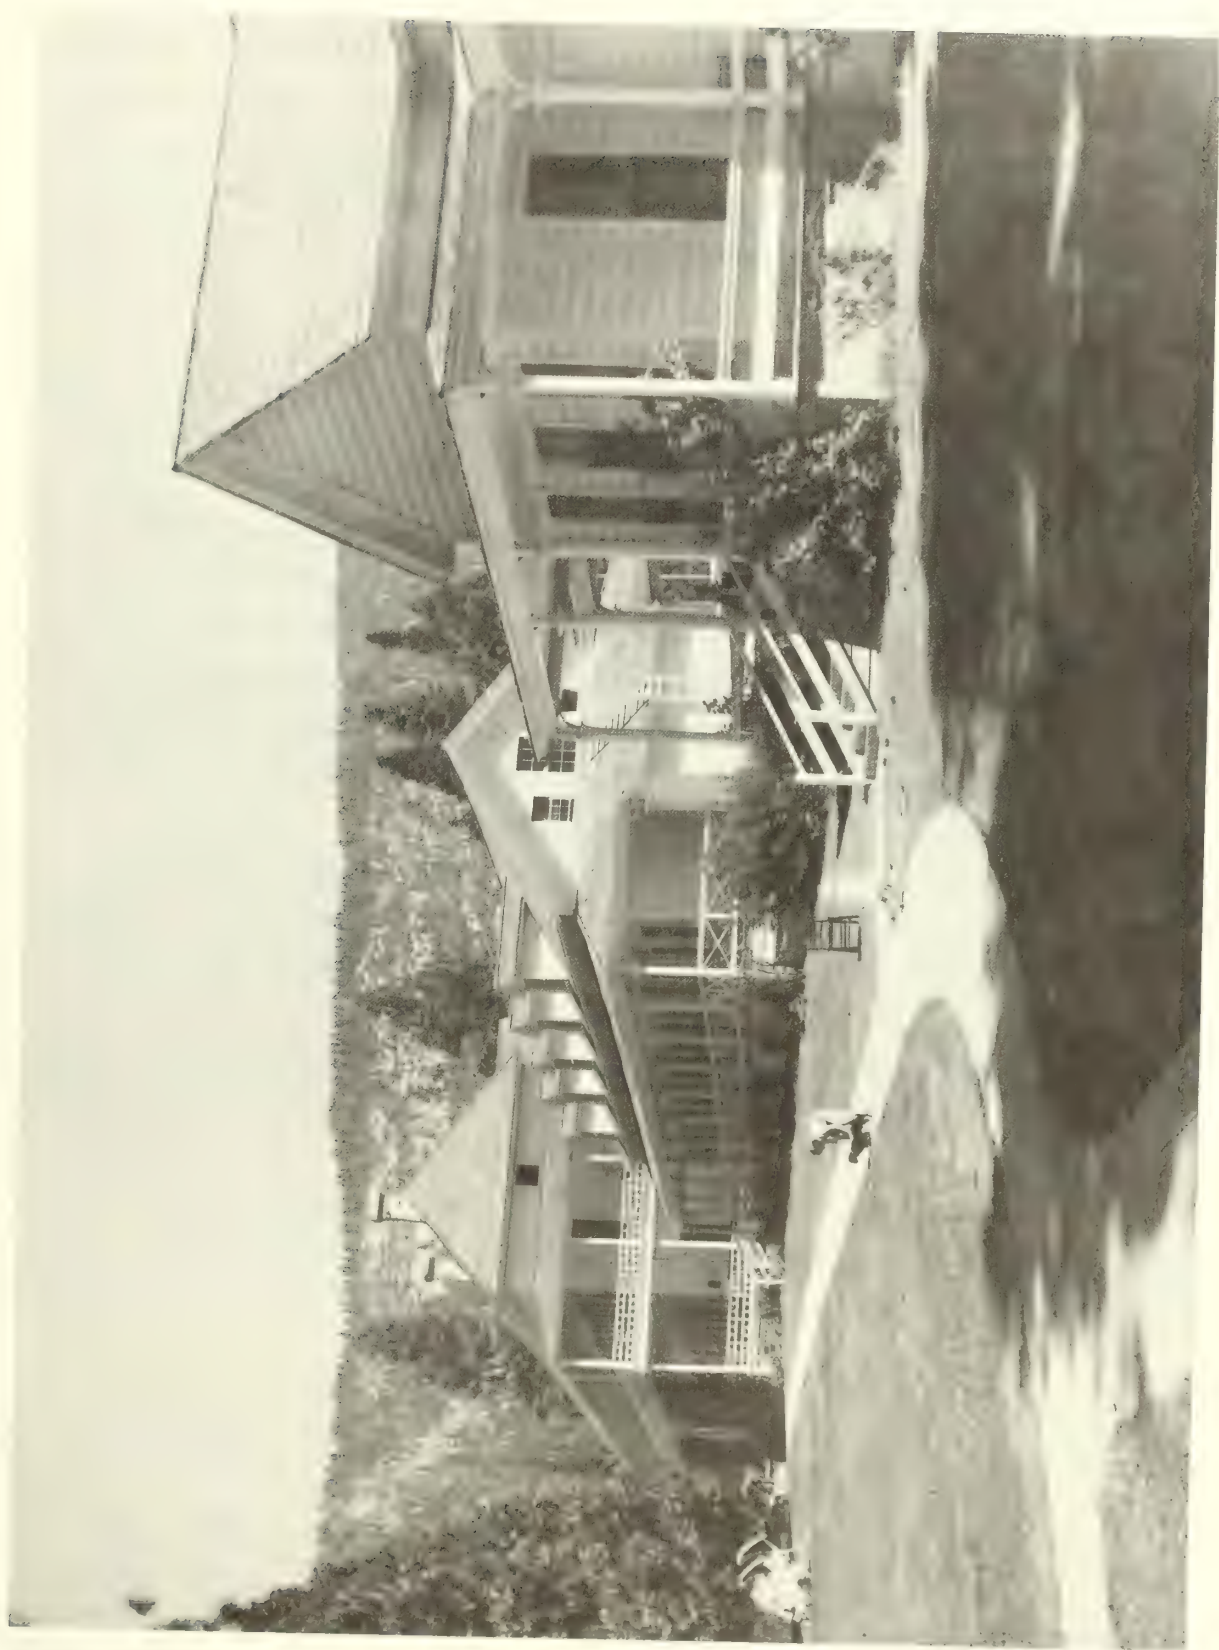
The photograph shows a spruced-up Long White, whose west porch had been freed of climbing vines.

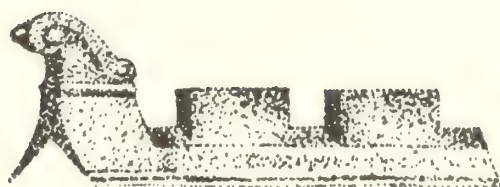
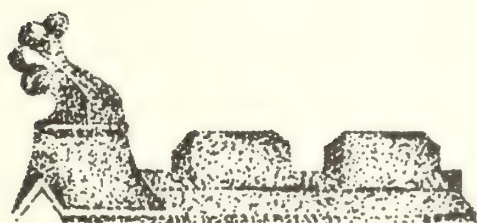
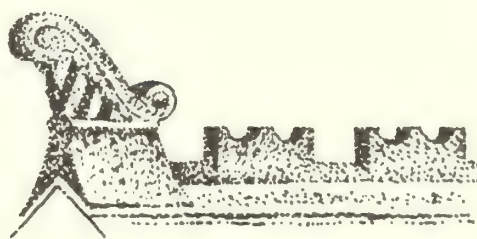
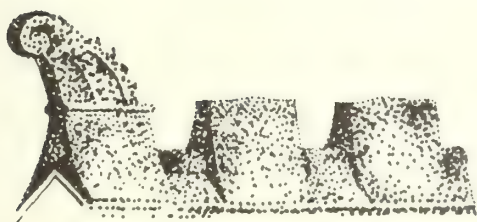
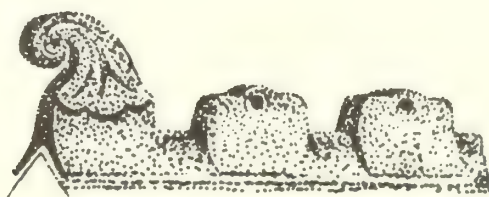
Four examples of galvanized iron crestings from an 1896 catalog of the Illinois Roofing and Supply Company of Chicago, Illinois.

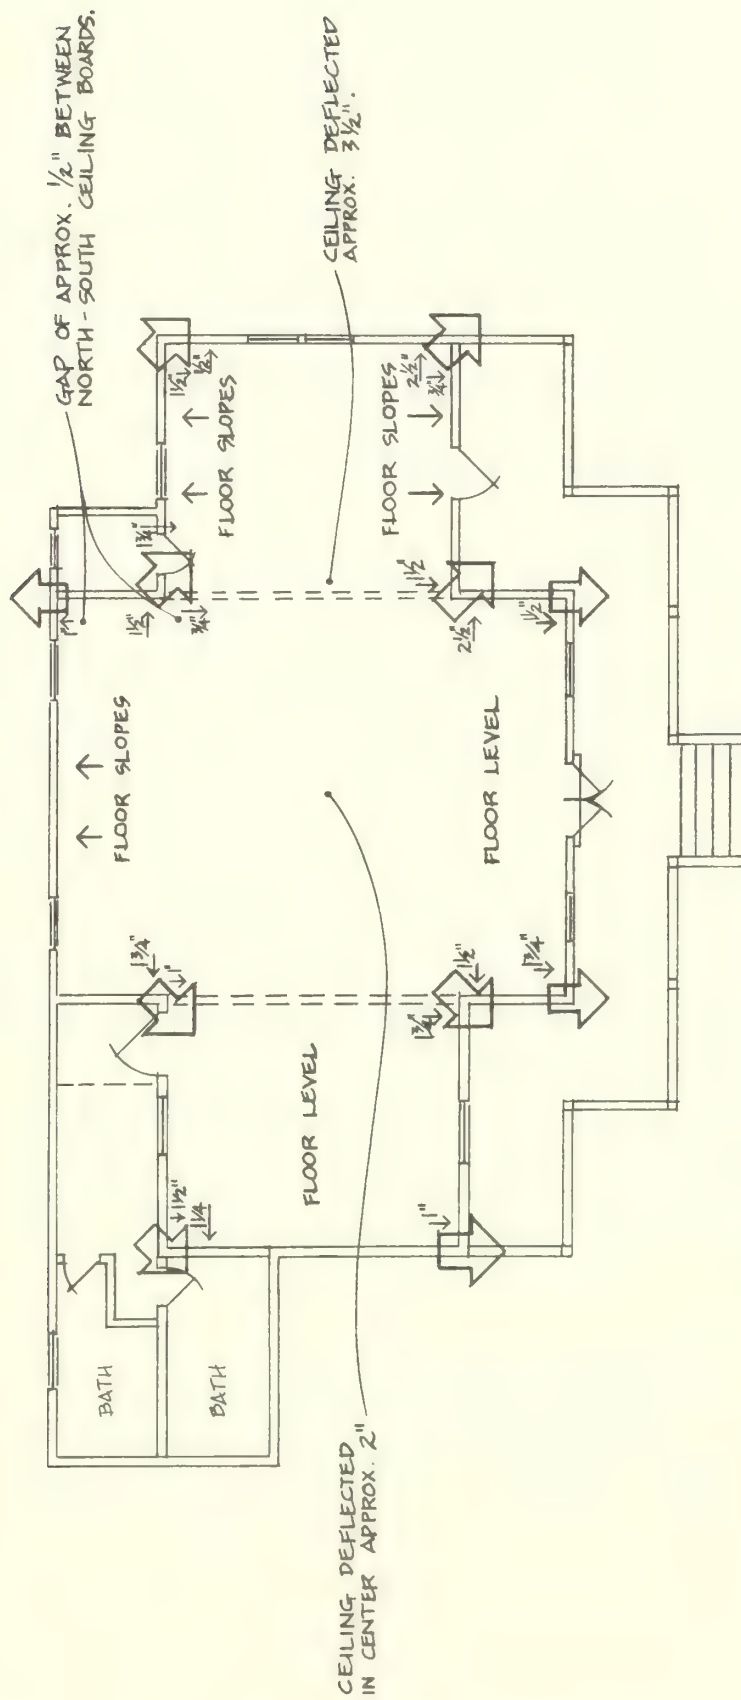
Large arrows indicate general movement trends.

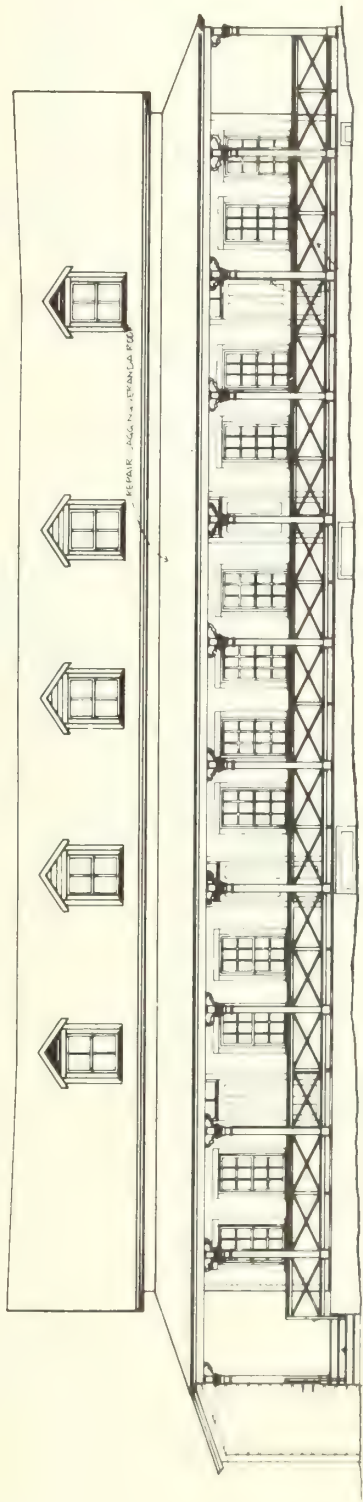
EAST ELEVATION

REPAIR JOISTS IN DECKING AND PORCH
